THE
SHOCK AND VIBRATION
BULLETIN

* DELAMINATION STUDIES OF IMPACTED COMPOSITE PLATES

C. A. Ross
University of Florida Graduate Engineering Center
Eglin AFB, Florida 32542

R. L. Sierakowski
Engineering Sciences Department, University of Florida
Gainesville, Florida 32611

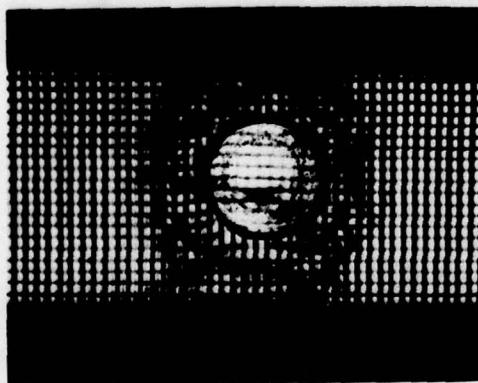
series of impact tests using $2.54\text{cm} \times .97\text{cm}$ diameter blunt ended penetrators have been performed on plates of various ply arrangements to examine (a) the successive stages as they develop in the delamination mechanism, (b) the influence of sequential lamina stacking on controlling the generator strip mechanism and (c) the effect of changes in fiber length on the observed delamination mechanisms. Initial testing reported on in [8] described some diagnostic type tests which were conducted in this study in order to better understand the mechanism of sequential lamina delamination. Controlled coupon specimens of nominal size ($.25\text{m} \times .1\text{m} \times .005\text{m}$) with three lamina consisting of different fiber numbers and orientation were impact tested at low velocities as shown in Table I. For these tests the top lamina or top and bottom lamina, were machined away to observe the threshold loading for noting the tendency to form a generator strip. For the specimens tested, an impact velocity of 12.7m/sec was found necessary to initiate the tendency for formation of a generator strip. Since for the most part the steel epoxy specimens appeared to show a symmetrical fracture pattern as shown in Figure 4,

Fig. 4 - Impacted Steel Epoxy Specimen
